Terrafix 150 blocks as remedial measure for cut slope failure

In April 2003, The City of Cape Town, Department of Transport, Roads and Stormwater, commissioned Jeffares & Green, a local civil engineering consulting firm, to undertake a geotechnical investigation and propose a design for remedial measures required to stabilise the cut slope failure at Suikerbossie Nek along Victoria Road between Camps Bay and Hout Bay.

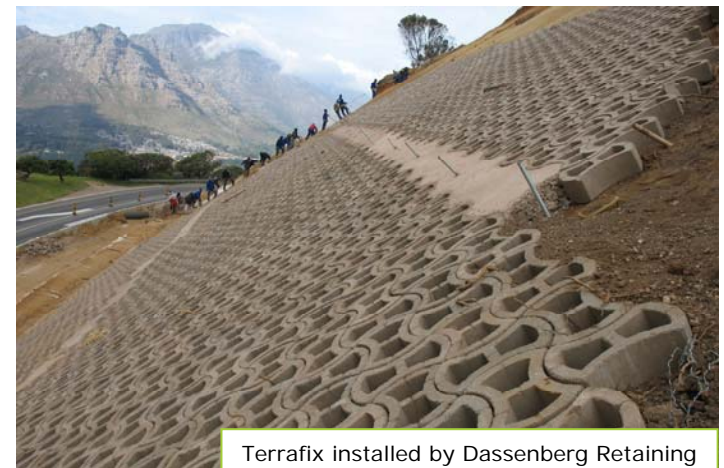
Terrafix installed by Dassenberg Retaining

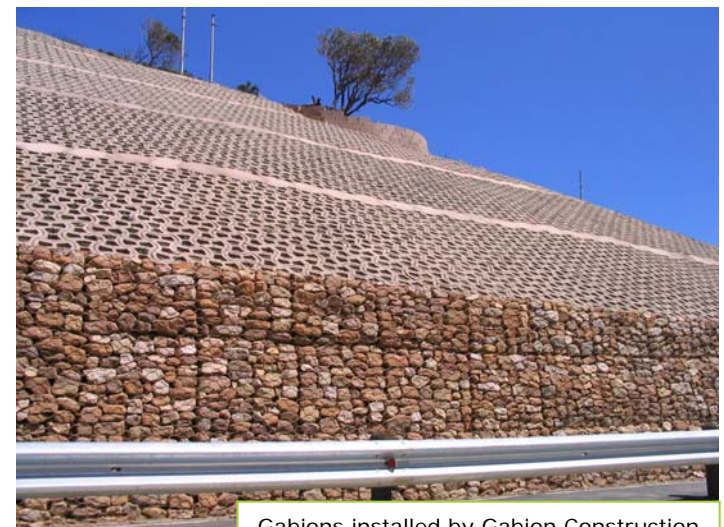
Gabions installed by Gabion Construction
