## How to achieve correct irrigation for a Terraforce® retaining wall

## **A successful irrigation implementation at Oasis Retirement Village. A case study:**

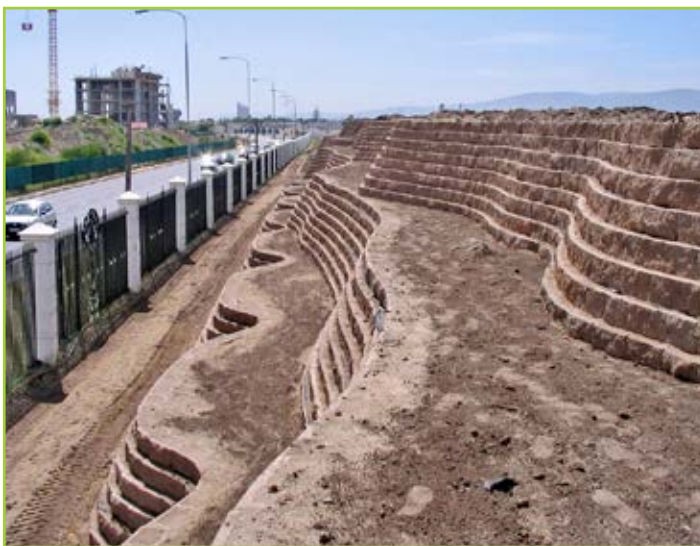
**Noise barrier before planting and irrigation at the Oasis Retirement Village, South Africa**

In 2005, a large noise barrier wall (or berm) using Terraforce L12 blocks was installed by Decorton Retaining System, Western Cape Terraforce recommended retaining wall contractor, running along busy Ratanga Road and facing the Oasis Retirement Village, Century City, South Africa.

The three undulating Terraces, specified by Planning Partnership, well-known Cape Town based landscape architects, were later used by the landscaping team from Real Landscapes to create instant hanging gardens with mostly water-wise indigenous planting.

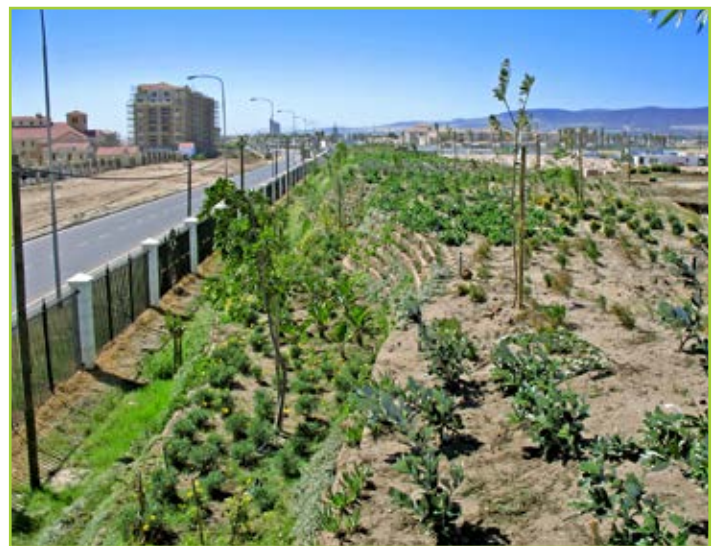
**Good irrigation successfully kickstarted total plant cover at the Retirement Village**

This is principally due to the first-rate irrigation system implemented at the end of 2005 by Cape Irrigation Systems, who installed the fully automated irrigation on all three levels of the retaining wall to ensure effective coverage of all areas.

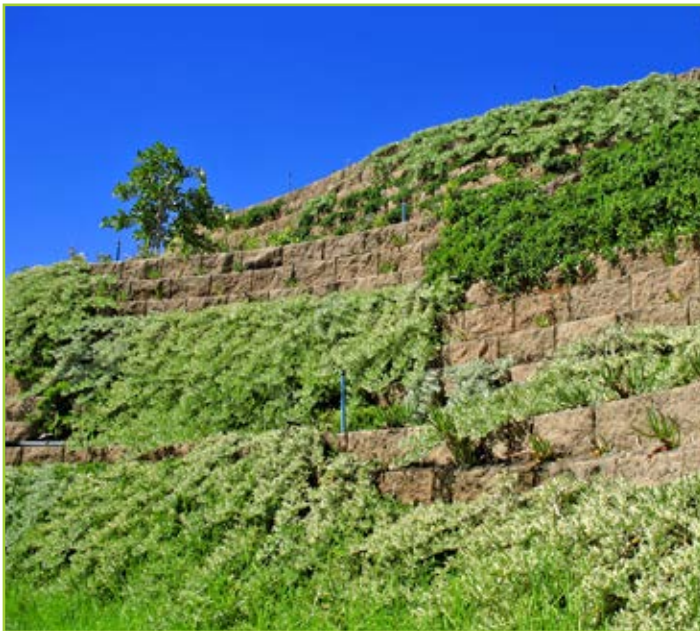
**Water-wise creepers and shrubs are thriving with strategically placed sprayers**

1. The irrigation on the berm consists of just over 200 static type shrub sprinklers with nozzles varying from 3m to 4,5m in radius.
2. A total of 30 gear-drive rotor sprinklers with a spray radius of 10m were also installed to stabilise the "back" of the retaining wall.
3. Approximately 700m of HDPE pipe was used for mainline reticulation and 1300m of Class 6 LDPS piping was used for the sprinkler lines.
4. A Hunter ICC modular controller, dedicated to irrigation only, runs 18 Hunter PGV 25mm solenoid valves.

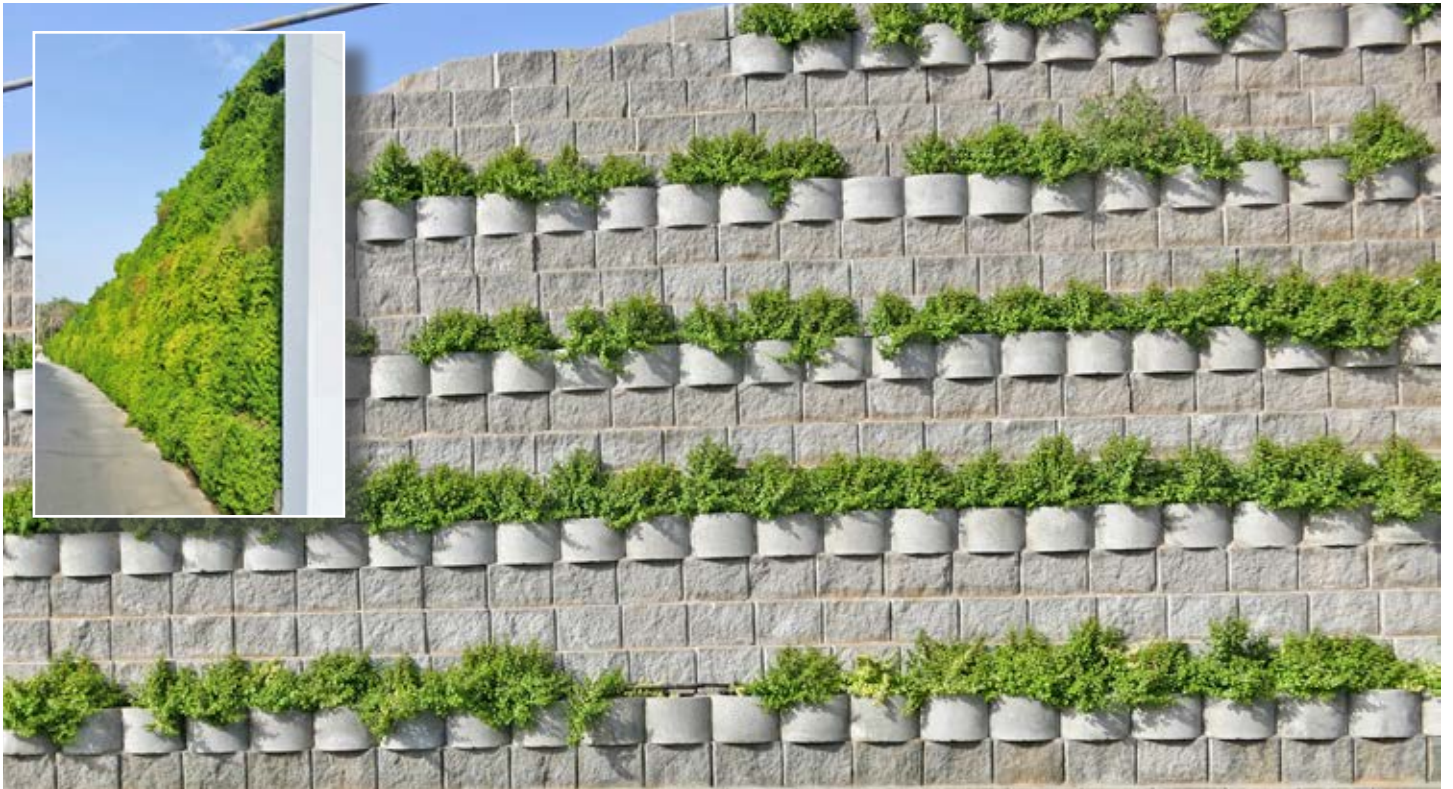
**Drip irrigation running along round face block rows that were installed at intervals between near vertical rock face rows.**

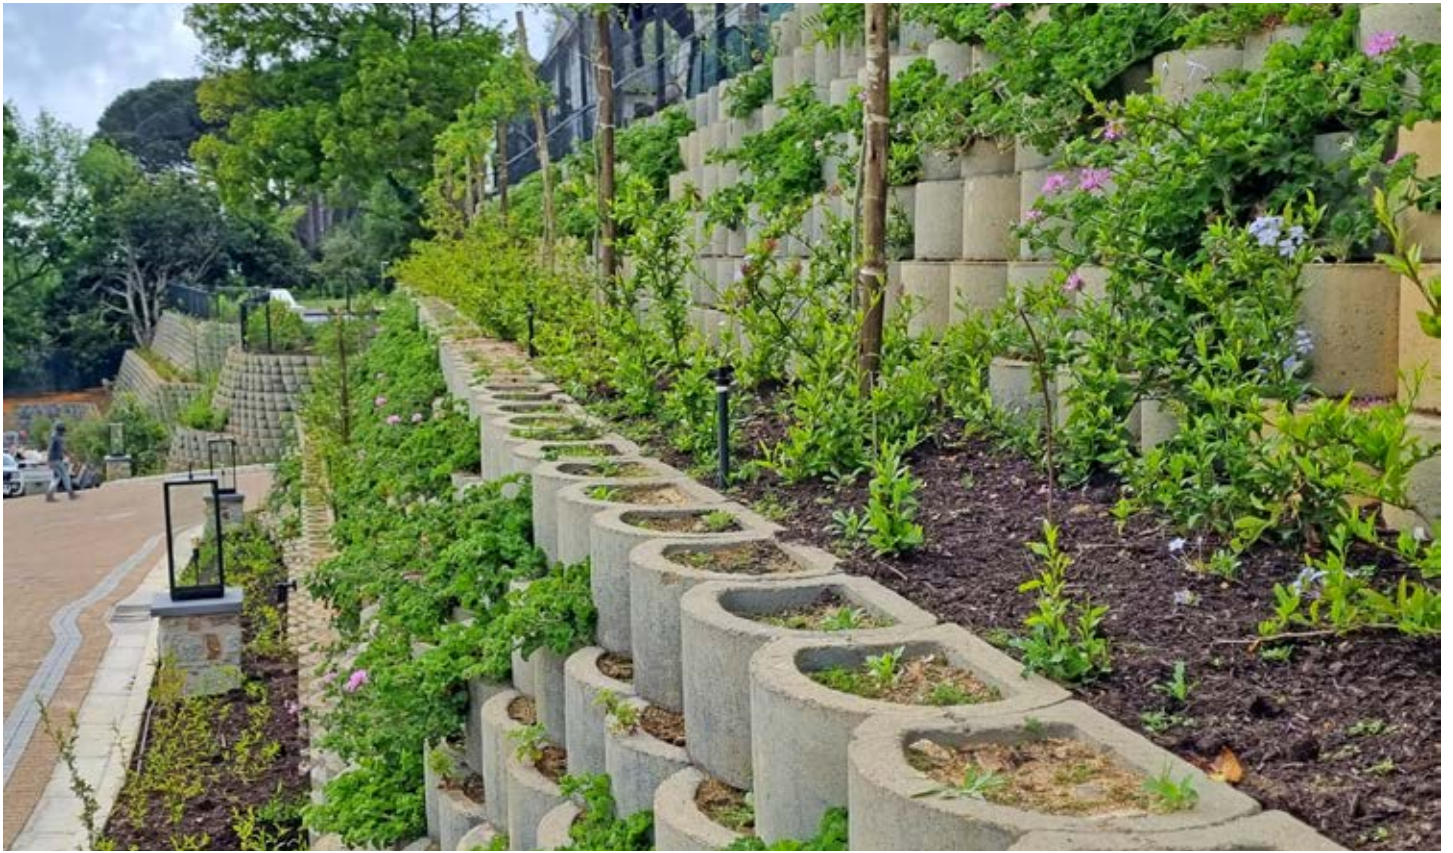
**Sprayers can propel the water so that it cascades downward into the plant pockets.**

Sprayers can propel the water to cascade downward into the plant pockets. For high wall sections, pipes can be placed at intermediate height levels against the wall, with spraying again occurring top-down.
