### Infrastructure challenges in Swaziland

During 2004, the Swaziland Electricity Board (SEB) of Mbabane was faced with an infrastructure maintenance question that had to be attended urgently, in a sustainable and cost-effective manner.

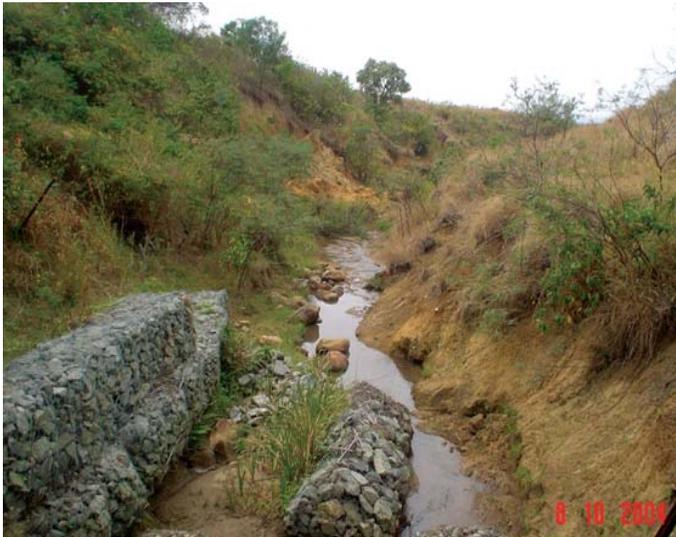
Badly eroded stream bed and sides

Holger Rust, CEO of Terraforce cc says: "A feeder canal in the Sigangeni community, that is feeding water to two hydro-electric power stations was being undermined by an adjacent stream, which caused the canal to develop cracks, with consequent leaks

"The stream has a catchment area of 2,5 Km<sup>2</sup>, with an anticipated 1 in 10 year flood of 10m<sup>3</sup>/sec. Average flow in the summer months is 3 to 3,4m<sup>3</sup>/sec. Soil in the area is considered dispersive, which led to the collapse of gabion weirs that were installed previously."

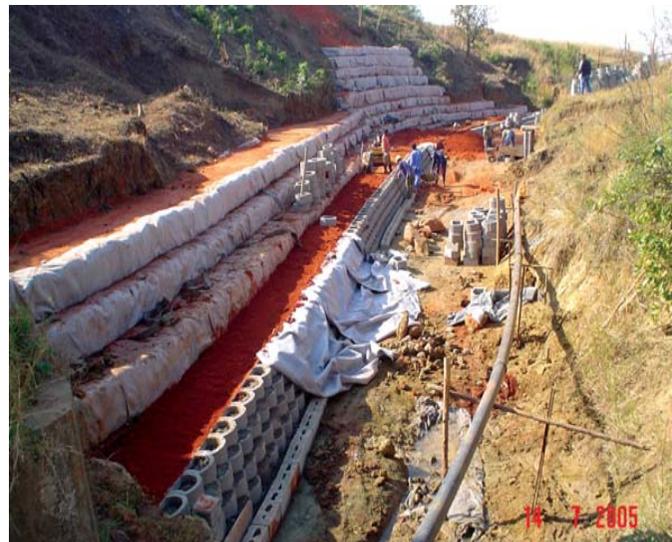
Progress on worst affected side, below feeder canal

Work commenced in May 2005 with the removal of as much unstable clay as safely possible on the critical section of the embankment, just below the feeder canal on the right hand side, facing up-stream. To avoid any unexpected collapses in this section, MiLiTo used recycled cement bags from their production plant, filled with a 3%

sand-cement mix, stacked in lifts of three bags high and wrapped in geo-fabric (tied back into the coarse backfill for a distance of up to 4m) for additional stability.

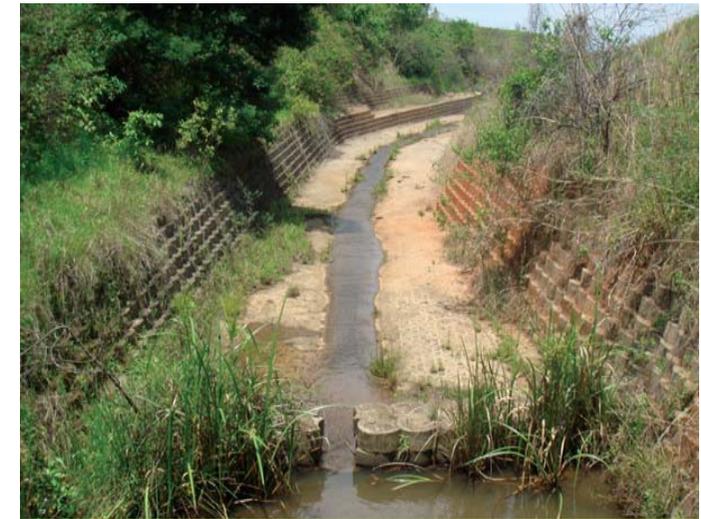
Looking downstream from stilling basin

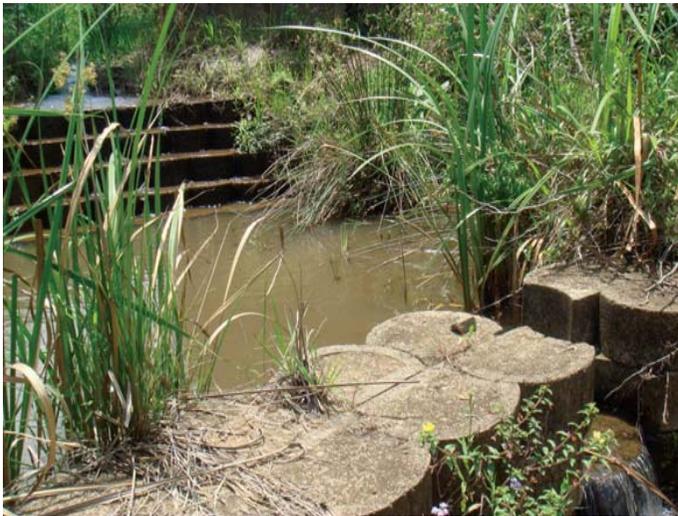
Weir and stilling basin - close-up

A series of four weirs, one of which functions as a stilling pool just below the original concrete foundation that supports the aqueduct where it crosses the stream, were constructed. These were built with single or double rows of concrete filled Terraforce L11 crb's, to slow down the substantial water velocity of the stream.

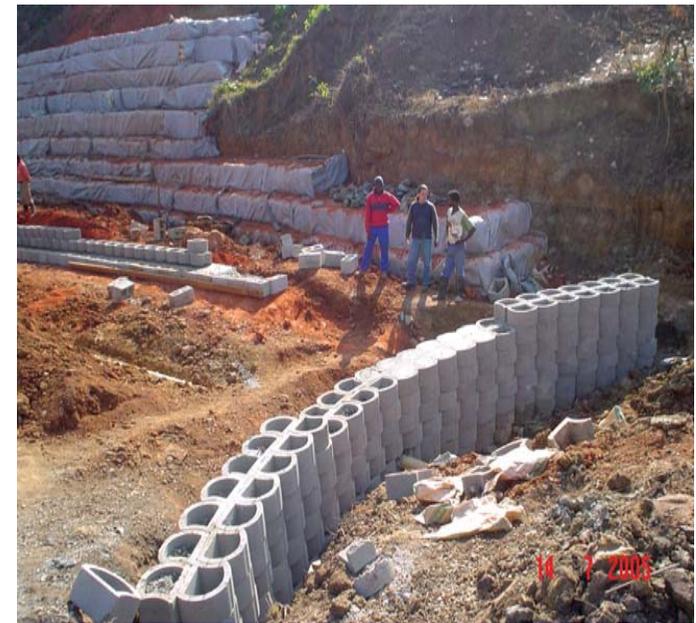
Weir under construction

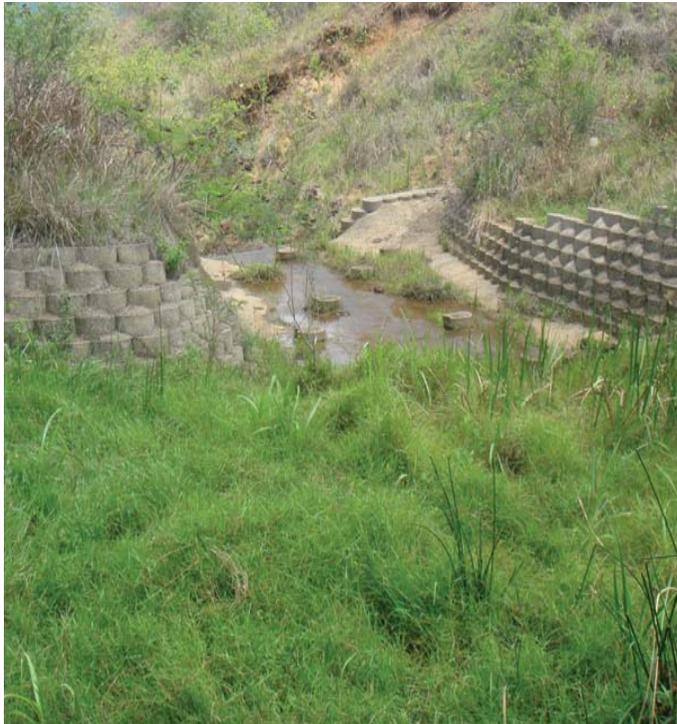
Last weir with velocity reducing buffers

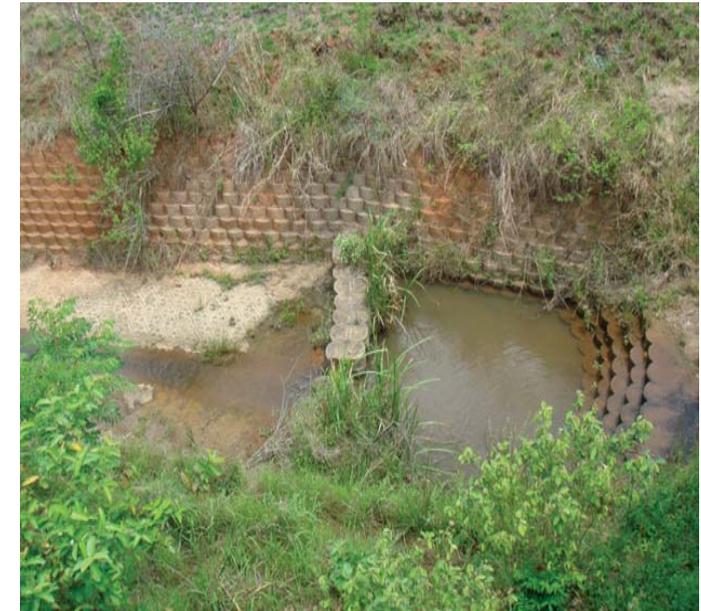
Second weir and stilling basin

Next the stream was filled to a level above that of the sidewall foundations and in-between the weirs and a protective layer installed with Terracrete blocks on a spun-bonded filter membrane and filled with 15 Mpa. no-fines concrete. The longitudinal subsoil drains proved to be a good investment as the water is constantly flowing from them in substantial quantities."

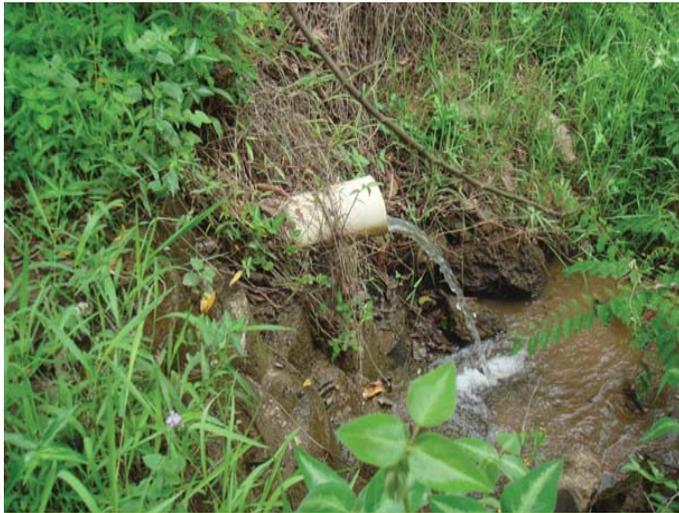
One of the sub-soil drain outlets

A further drainage measure was necessary in the form of longitudinal subsoil drainage pipes - 110 mm diameter, slotted as well as wrapped into geo-fabric and coarse gravel - behind the crb's at foundation level and one meter above foundation level."

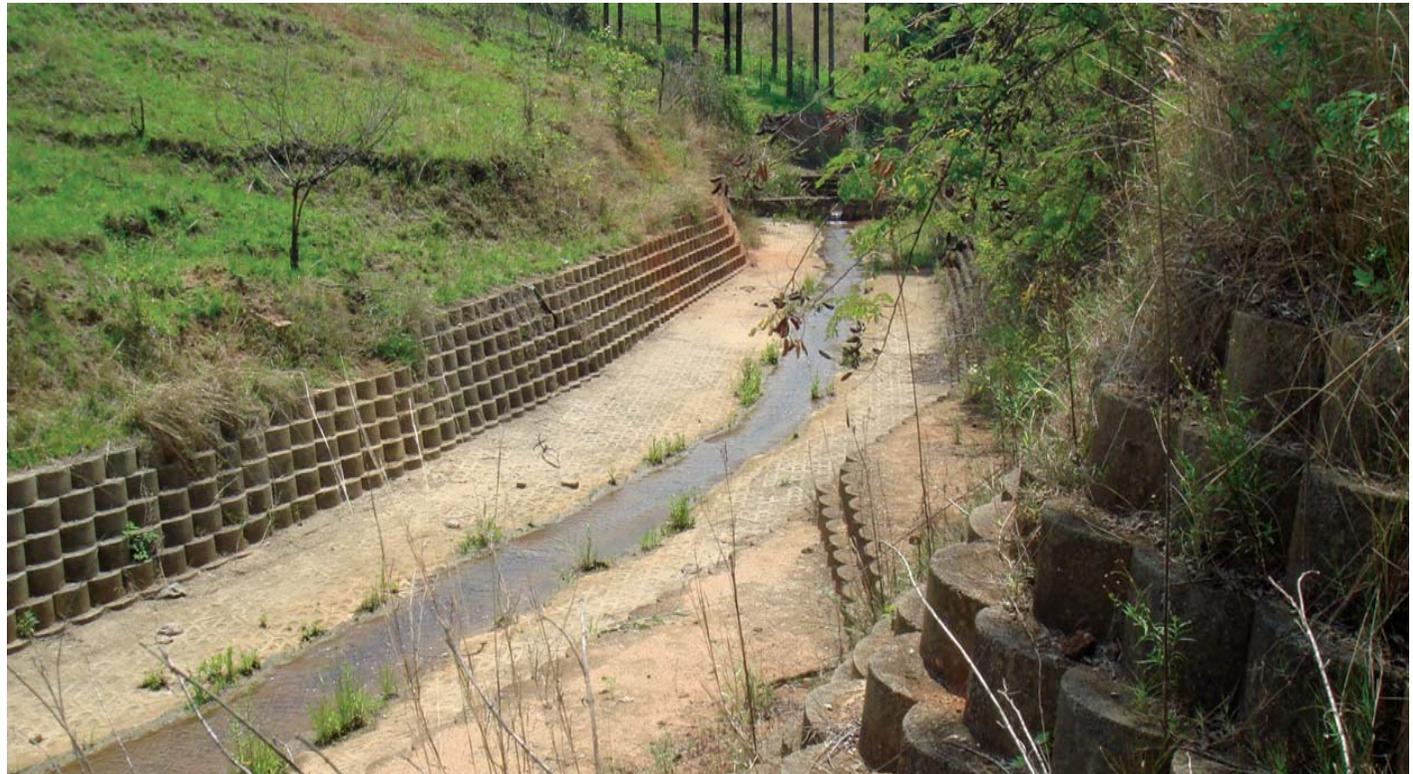
Looking upstream from stilling basin
