Good irrigation goes a long way

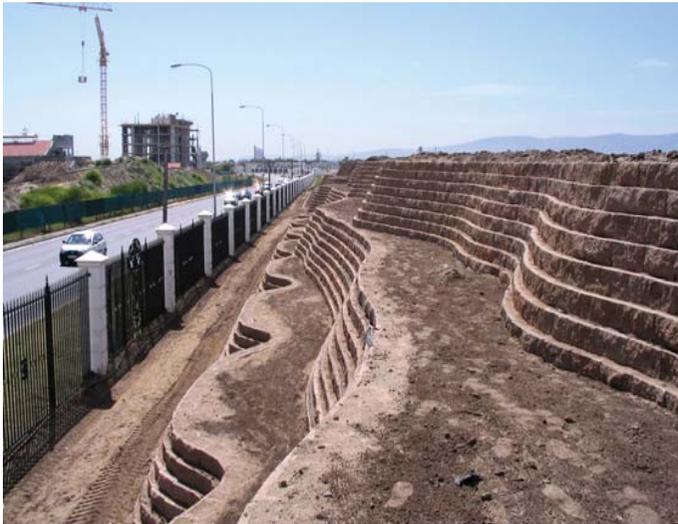
The noise barrier before planting

A well planted and irrigated retaining wall, besides being more structurally safe, also looks good. In 2005, a large noise barrier wall (or berm) using Terraforce L12 blocks was installed by Decorton Retaining, Cape based retaining wall contractor, at the Oasis Retirement Village near Cape Town. The three meandering Terraces, specified by Planning Partnership, well known landscape architects, were later used by the landscaping team from Real Landscapes to create instant hanging gardens with mostly water wise indigenous planting. In October that year, the project won the Premier award for retaining block walls, the Cathay Pigments Trophy, impressing the judges with its lush vegetation softening the overall visual impact of the wall.

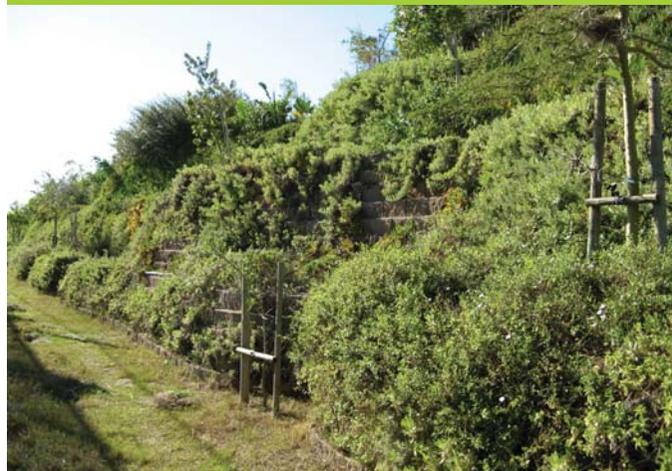
Two years later and the wall is almost hidden

Now, almost two years later, after one major extension to the project in the form of a double sided, near vertical noise barrier and considerable growth of the established indigenous vegetation, the project continues to be a flourishing success. The wall is well overgrown and the plants look healthy. Charl Le Roux of Cape Irrigation Systems feels that this is largely due to a good irrigation system that was implemented end of 2005: "The complete irrigation system was installed in three phases, following the construction programme, with the first phase being the Health Care Centre as well as the screening berm along Ratanga Road. Fully automated irrigation was installed on all three levels of the retaining wall to ensure sufficient and efficient coverage of all areas."

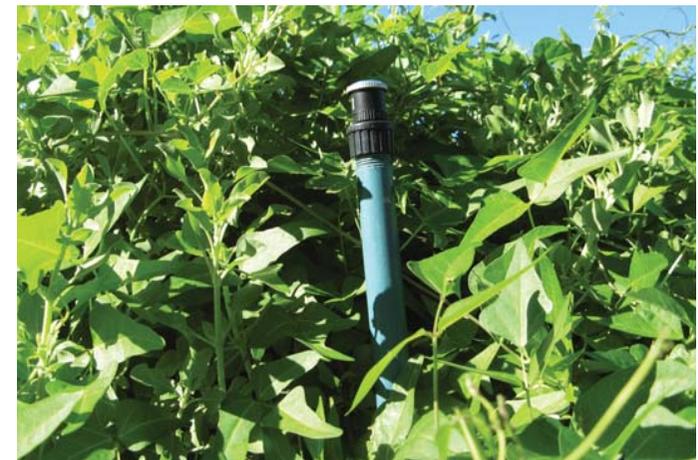
A sprinkler at L'ormarins retaining wall

He adds that the "blanket type" overhead irrigation system chosen can easily reach all areas in the terraced type installation such as this one and would only be hard pressed on very high walls were supplementary measures would have to be considered. At another installation at L'Ormarins Wine Estate near Franschhoek, Cape Irrigation Systems put in place a similar system that is successfully getting water to all areas on a 9m high Terraforce wall built by Decorton Retaining.

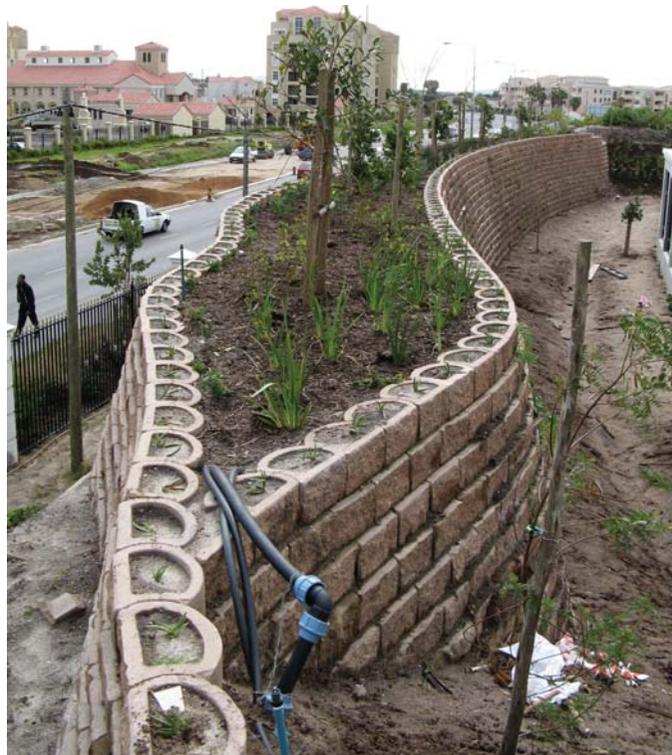
Near vertical, double sided extension at Oasis

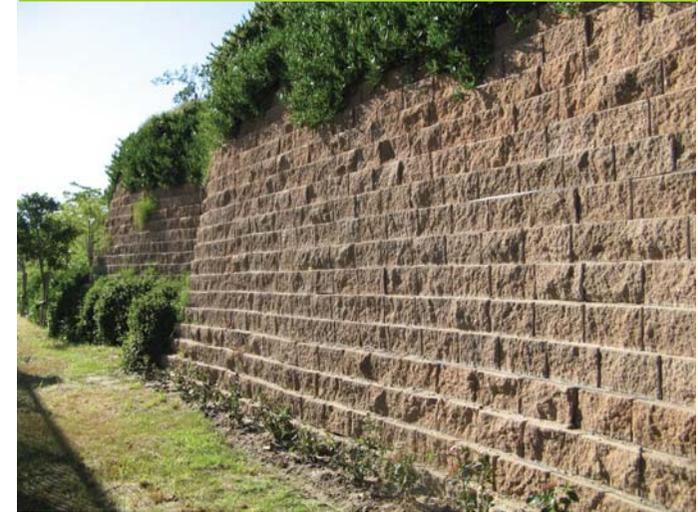
The extension converted to hanging gardens
