## Installation Instructions – 4x4 stairs and low retaining wall

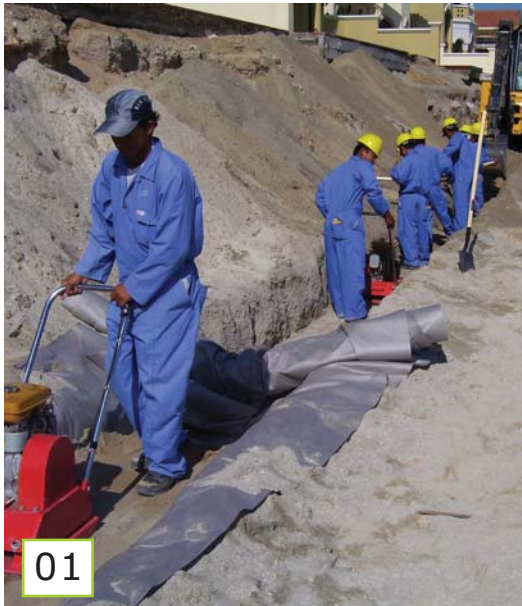
Image 01: Well draining sand slopes to be retained with three terrace walls. Excavate foundation, compact trench, place geofabric wrap around, fill and compact sand foundation.

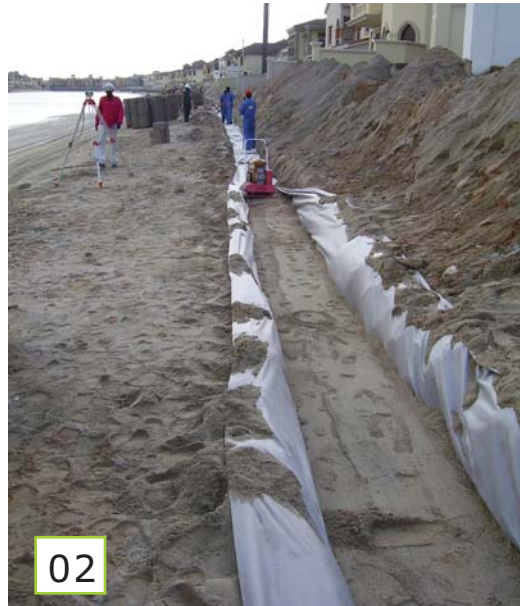
Image 02: Foundation of sand wrapped in geofabric, compacted and then closed with fold-over fabric

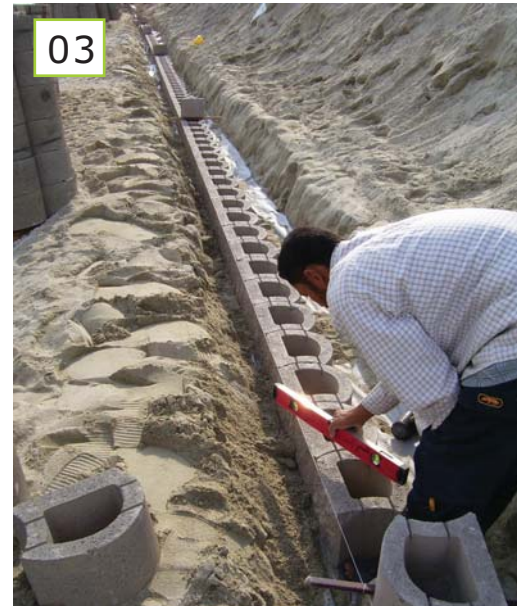
Image 03: Packing with line and level. No gaps are allowed between blocks. Depending on the climate and soil conditions it will be necessary to install a drainage layer and sub soil drain pipe behind the blocks.

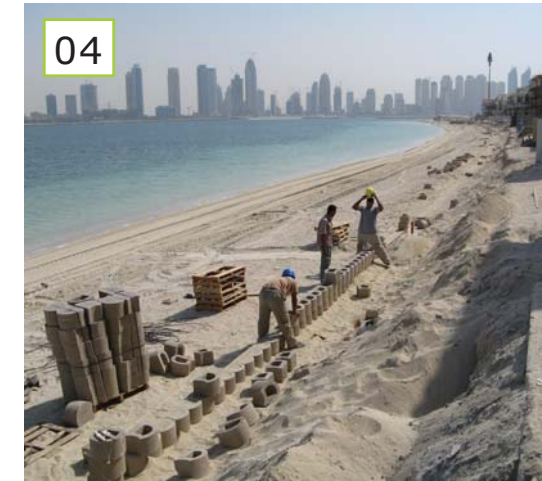
Image 04: Terrace wall under construction while backfill is brought in for compaction. Compact to specification in layers not exceeding block height and hand compact inside blocks.

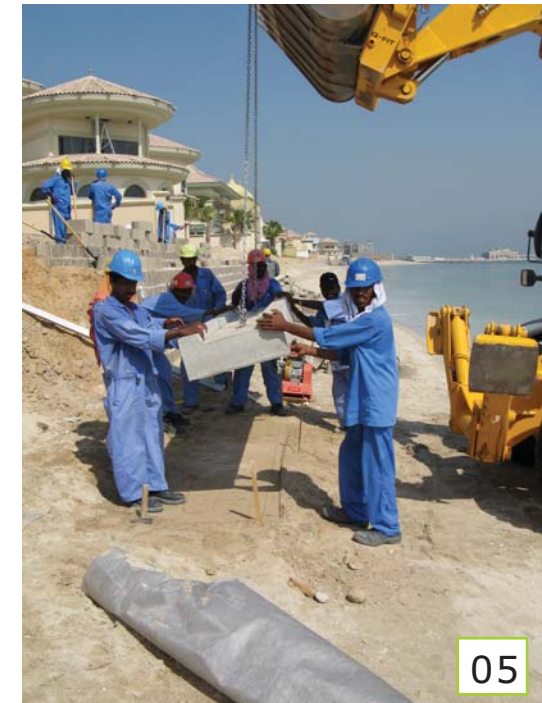
Image 05: Placing of pre-cast concrete foundation for the stairways, alternatively insitu foundations can be used where so specified.

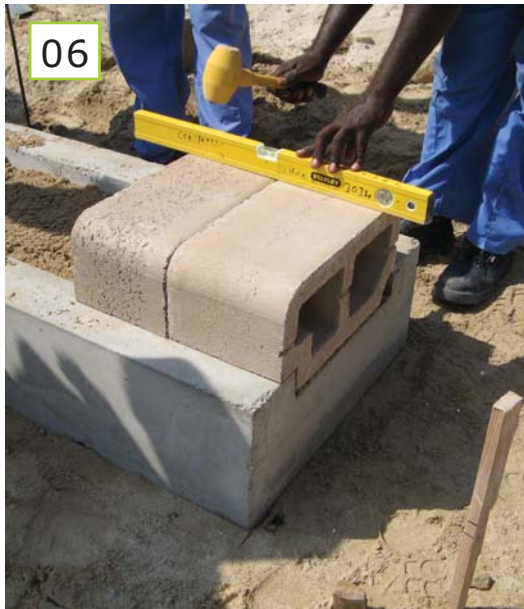
Image 06: First stair blocks are placed perfectly level on the foundation. Carefully check levels and dimensions to ensure that the top row of the steps ends at the desired point. Consider geofabric or cement stabilised backfill behind blocks where fine, soft sand is used.

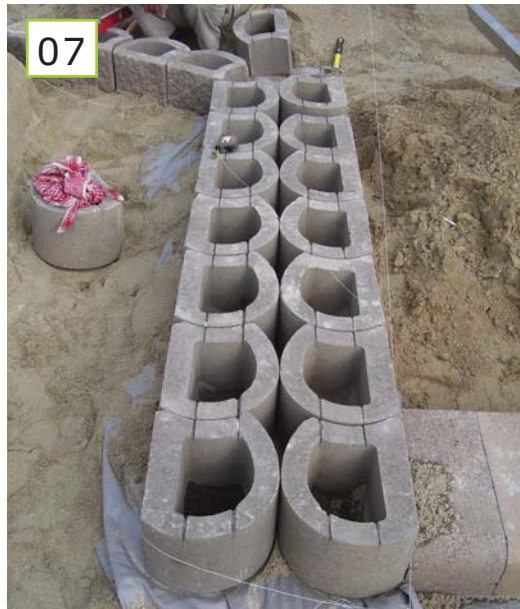
Image 07: First row of double wing-wall blocks placed on geofabric and sand foundation.

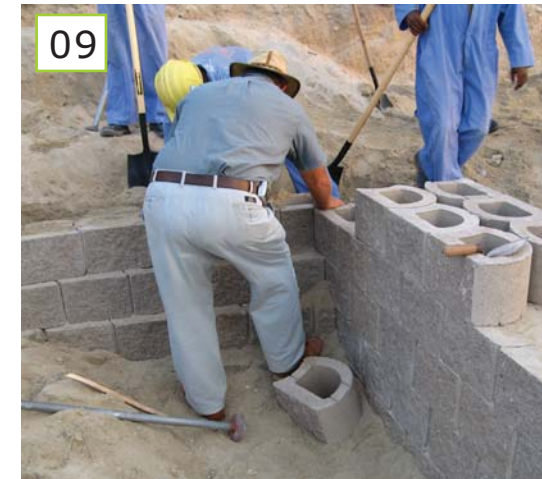
Image 09: Keying in of double wing-walls with terrace walls. This is not possible without maintaining a firm grip on levels.

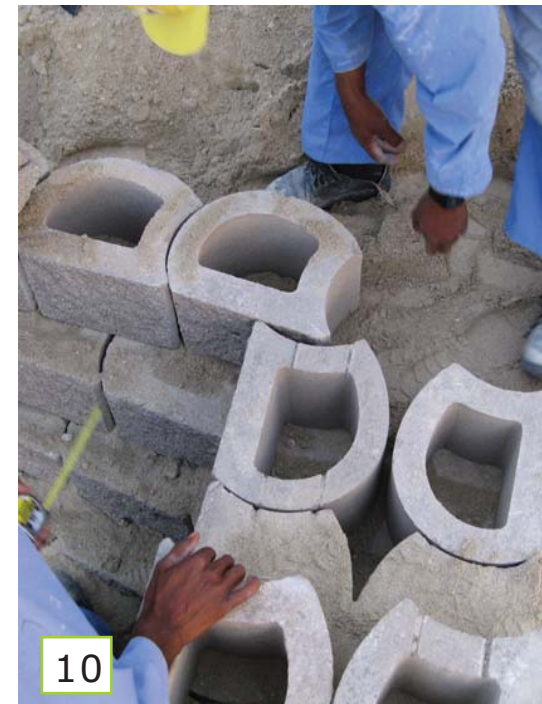
Image 10: In detail prior to filling and compacting behind and inside the blocks. Compact inside with small hand compactors and allow no gaps between blocks.

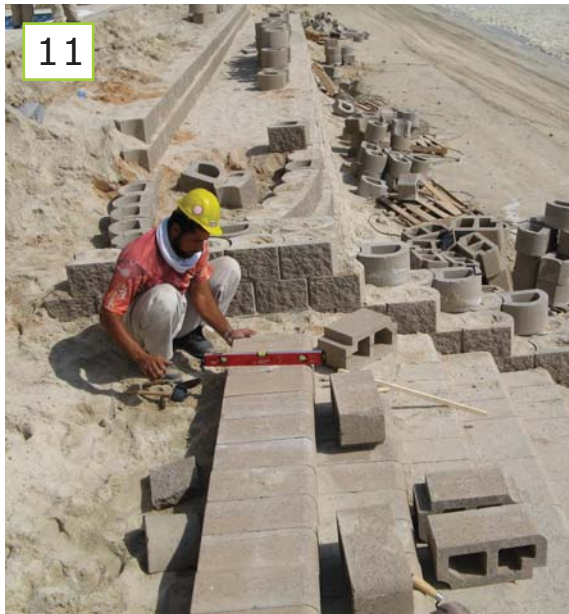
Image 11: Terrace walls complete in the background and stairs almost at final level.

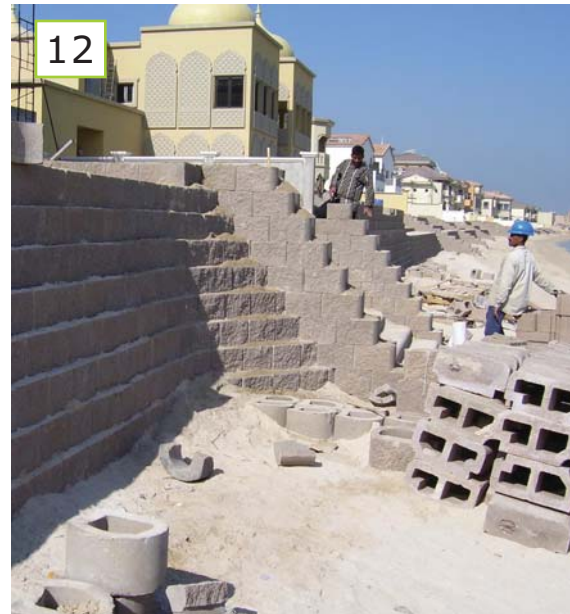
Image 12: Nearing completion of the staircase, keyed into terrace walls.

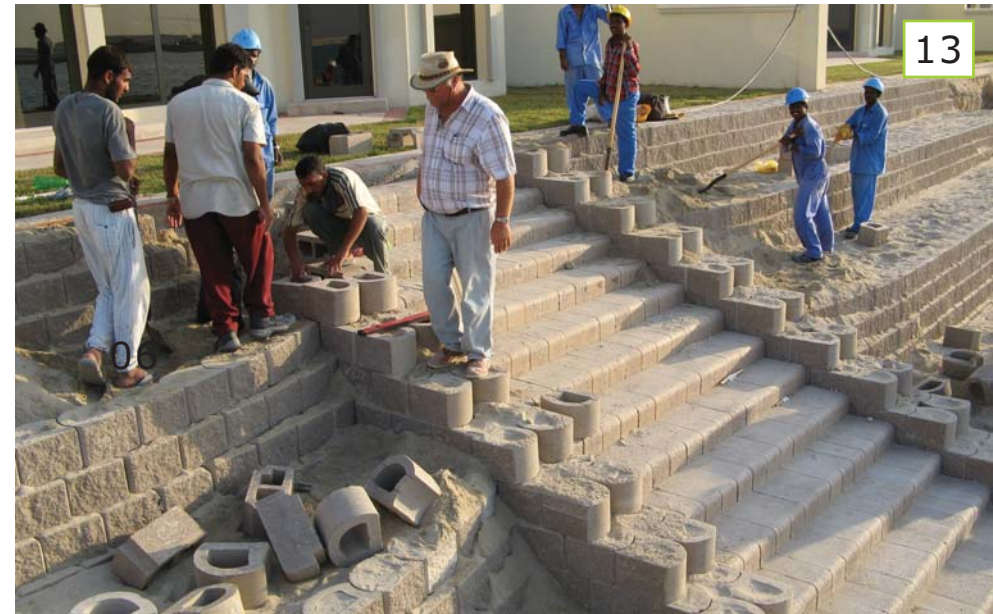
Image 13: Adding the final touches. Top blocks of double wing-walls to be filled with concrete in matching colour and brushed for a rough finish.
