Terrafix 150 blocks as remedial measure for cut slope failure

In April 2003, The City of Cape Town, Department of Transport, Roads and Stormwater, commissioned Jeffares & Green, a local civil engineering consulting firm, to undertake a geotechnical investigation and propose a design for remedial measures required to stabilise the cut slope failure at Suikerbossie Nek along Victoria Road between Camps Bay and Hout Bay.

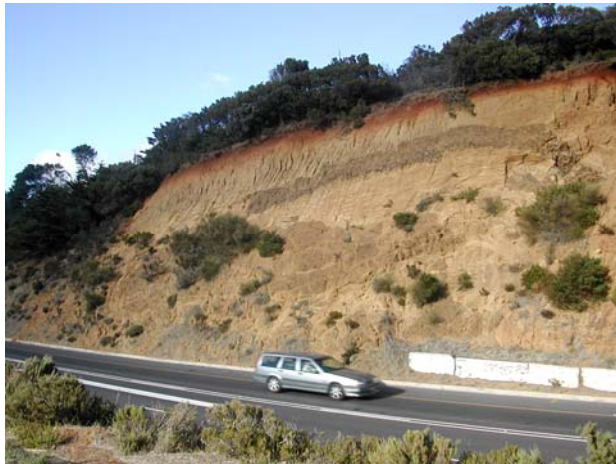
The recent detailed field survey, coupled with observations over a number of years, led to the conclusion that the erosion and collapses at the site were essentially due to the slope being cut at an angle initially stable in terms of wedge or slip circle failure, but not stable in terms of long-term erosion and/or slip failure once weathering sufficiently reduced the surficial strength parameters.

The site comprises a road cutting originally cut at roughly 50° into very soft rock - very highly weathered granite and dolerite - where a dolerite dyke crosses the road. Says Mike van Wieringen of M. van Wieringen and Associates: "Weathering of the face coupled with the convex shape of the slope and diversion of sub-surface water by the dyke, ultimately resulted in planar slip failures with a gradually advancing head scarp of up to 4 m in height, discharging onto the road during the wet seasons."

In addition, it was found that the non-functional surface cut-off drains situated above the cut face also contributed to and accelerated erosion and/or slip failure and lack of regular maintenance has led to silting up of the drain as well as choking by vegetation - with consequential over-topping.

A combination of a near vertical gabion toe wall up to 2,5 m high at the base of the cut, with a 35° Terrafix covered slope above, topped by a concrete-lined cut-off drain, was ultimately selected. The gabions match numerous other gabion structures along Victoria Road and a feature of these particular ones, as developed by Gabion Construction, is the smooth unstepped nature of the face and the top of the wall as it follows the contour of the cut face.

Van Wieringen explains that Terrafix 150 blocks were selected in order to trap the maximum amount of topsoil on the face thus enabling plant growth, to prevent erosion by surface run-off and to retard the weathering process. "Because of the very large area covered on a curved surface, near-horizontal concrete infill walers were introduced at 5 m intervals to take up the uneven spaces developed between adjacent panels."

"These were anchored to the slope with anchor bars in order to reduce any possible downward sliding force coming to bear on the gabion wall. The maximum density of Terrafix laying pattern (10 blocks per m²) was used so as to maintain an interlock between blocks against lateral sliding should support from below be disturbed in any way."
