### Vintage: ten years in service

A newly cut driveway into a relatively stable shale slope made these retaining walls necessary.

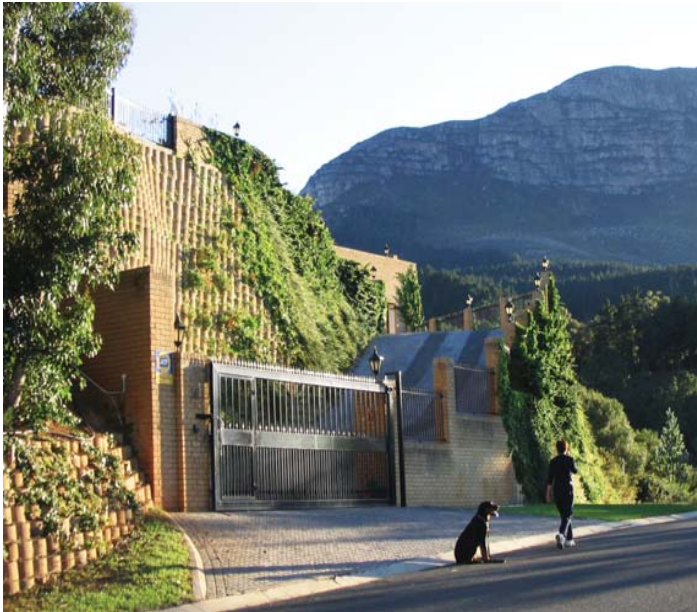
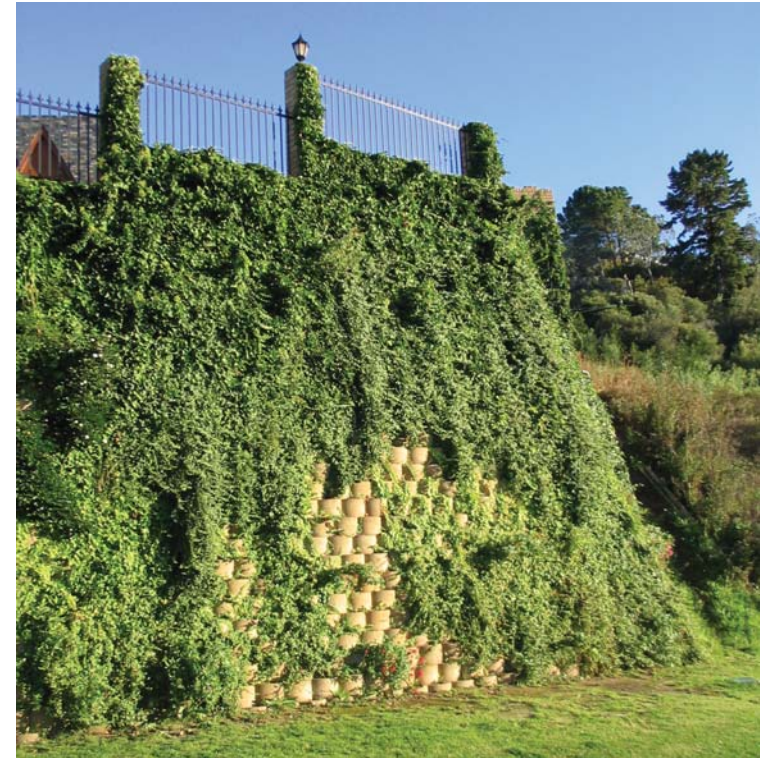
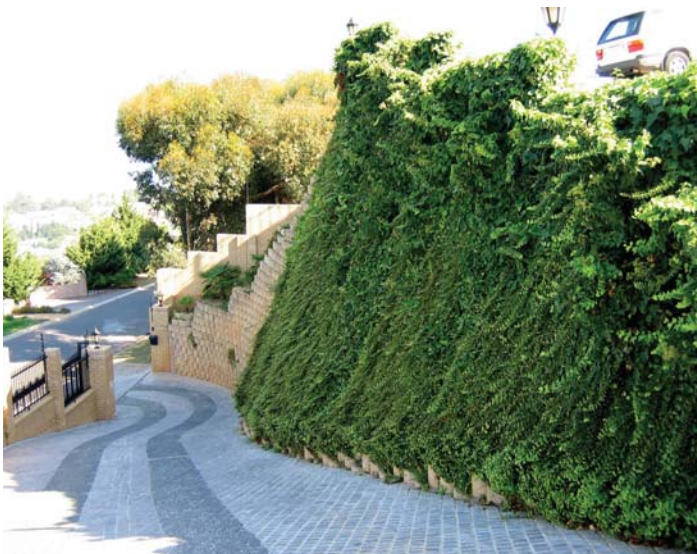
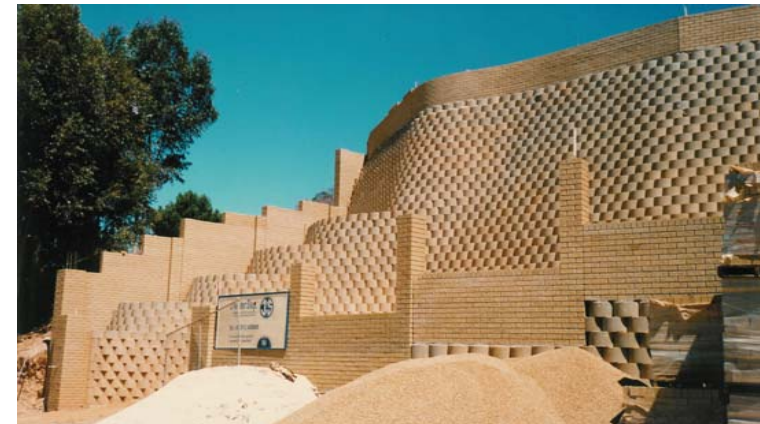
Space restrictions ruled out the over-excavation that would be required for composite retaining. Convex indentations and protrusions were incorporated with ease.

A comprehensive drainage system was also specified behind the total wall area, complete with a surface drainage channel above the wall.

Face brick and wrought iron fencing with cobble paving stones rounded off this tricky undertaking, fulfilling all aesthetic expectations.

Today, the installation is almost completely covered in vegetation, softening the overall look even more.
