### Total Turnaround for Suburbs Wetland

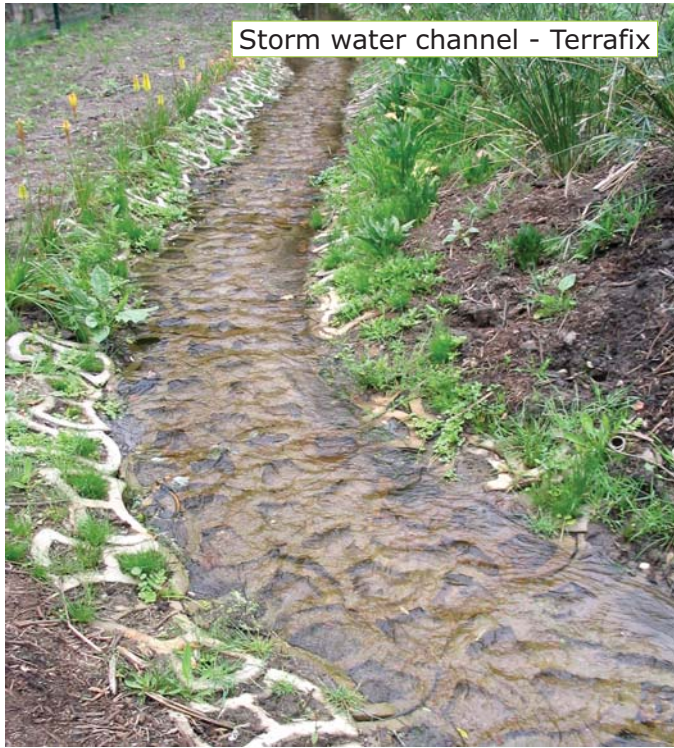
Storm water channel - Terraforce

In the middle of January channels were dug to divert the water from the core area, but before work could start in earnest, other issues had to be dealt with. The site is situated in the middle of a suburb with limited working space and all construction methods had to be

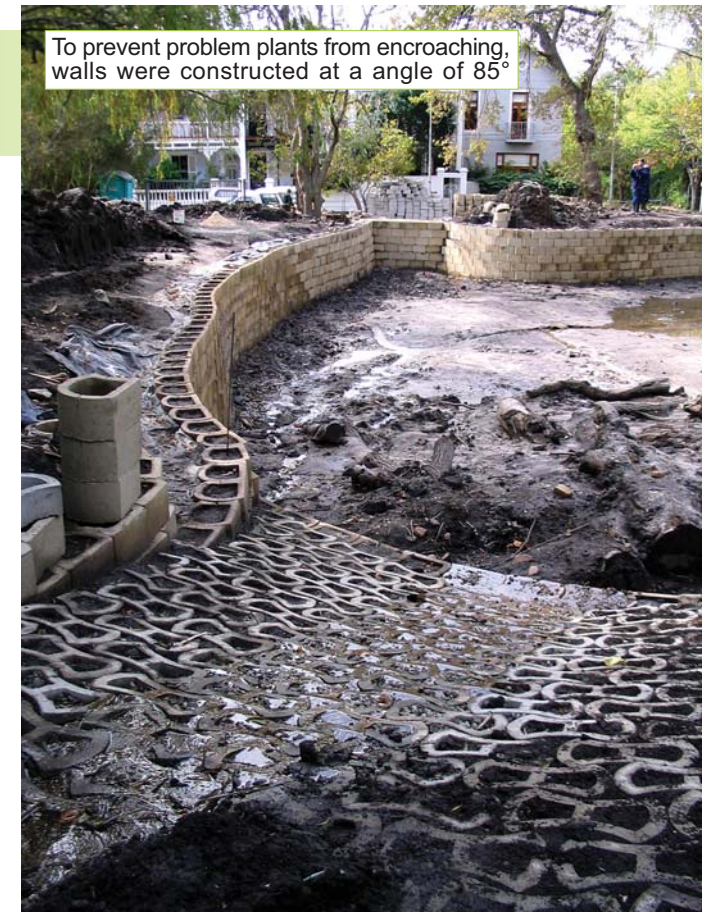
To prevent problem plants from encroaching, walls were constructed at an angle of 85°

To prevent problem plants from encroaching with ease, the walls are constructed at a steep angle of 85°, while the in and outlet areas will allow migration of various creatures even when water flow has to be diverted for maintenance purposes. Swanepoel envisioned a pool with crystal clear water, conducive to indigenous fauna and flora. To this end Ernst van Jaarsveld of Kirstenbosch National Botanical Gardens was consulted.
