Vintage: ten years in service

A newly cut driveway into a relatively stable shale slope made these retaining walls necessary.

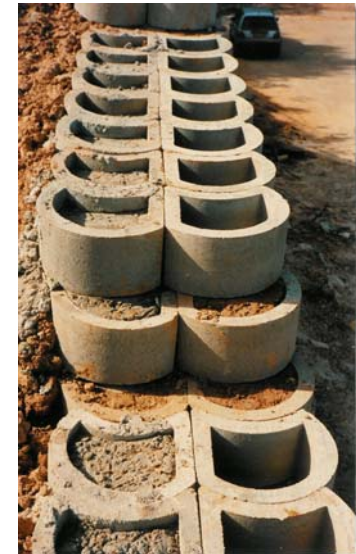
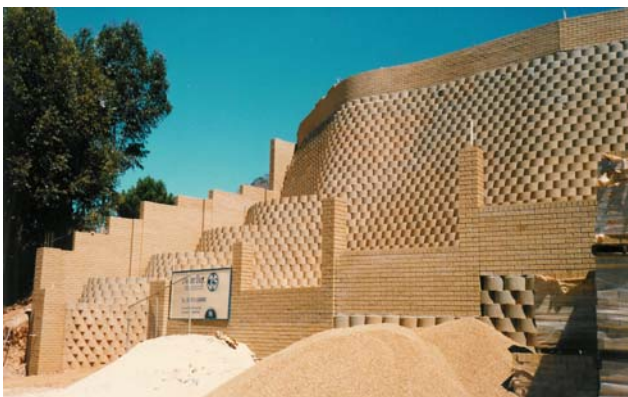
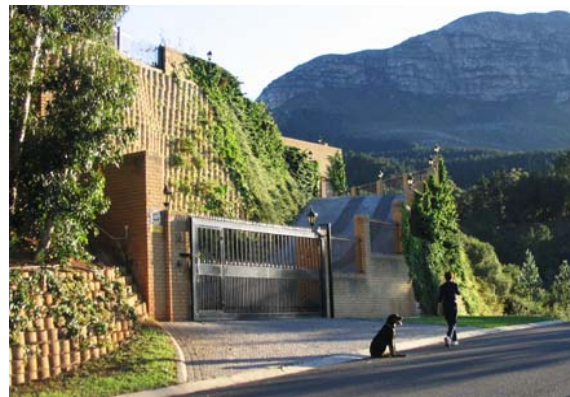
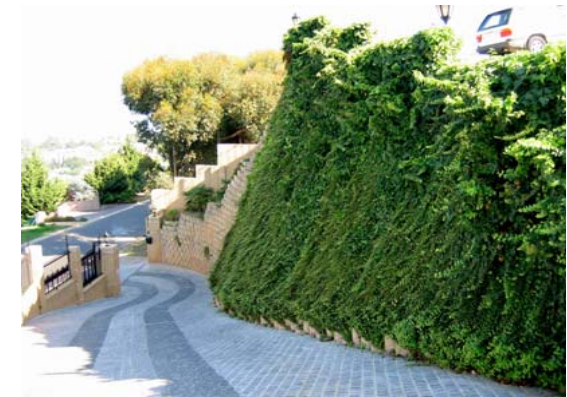
Space restrictions ruled out the over-excavation that would be required for composite retaining. Convex indentations and protrusions were incorporated with ease.

A comprehensive drainage system was also specified behind the total wall area, complete with a surface drainage channel above the wall.

Face brick and wrought iron fencing with cobble paving stones rounded off this tricky undertaking, fulfilling all aesthetic expectations.

Today, the installation is almost completely covered in vegetation, softening the overall look even more.
